Manhole Inspection Summary

Manhole # S11KK1012MH

Insp Date: **3/5/09 10:31 AM**

Location Address: **3105 SUMTER AVE**

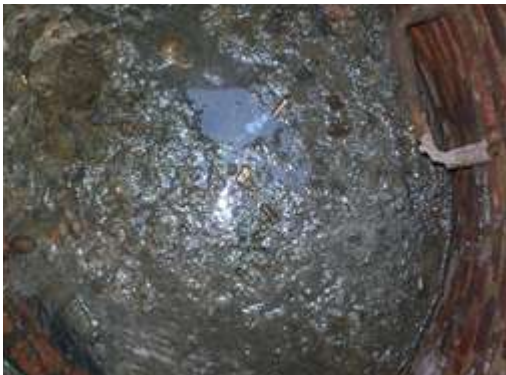
Defect 4

Surcharge ☒ **Evidence Of Surcharge** Depth: **2** (ft.) ☐ Active Surcharge Present

EVIDENCE OF SURCHARGE ON
ENTIRE BENCH

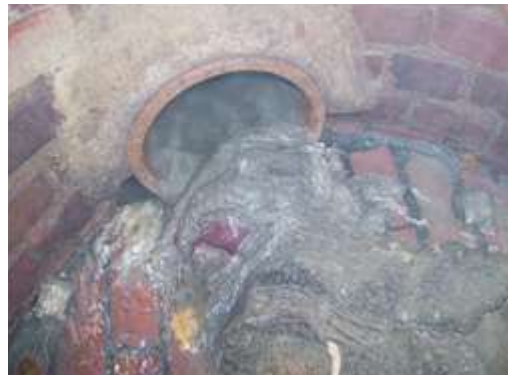
Defect 1

Condition: ☐ Sound ☐ Cracked ☐ Root Intrusion ☐ Deteriorated ☐ Leaks ☒ **Debris**

DEBRIS AT THE END OF THE
INCOMING LINE

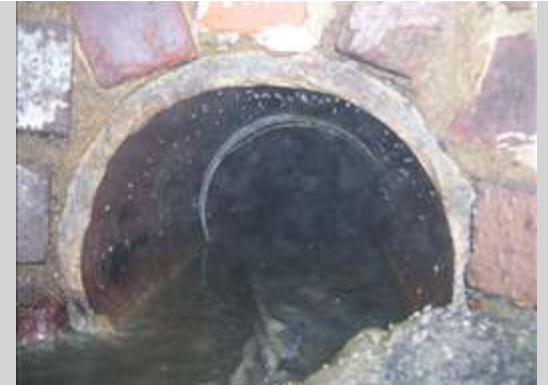
12 O'Clock Outflow

8 in. Circular Gravity Sewer
Pipe Out @ 12 O'Clock

Pipe Height: (in.) Direct
Pipe Material: **Clay** ☐ Pipe Lined
Invert Depth: **5.82** (ft.) Flow Characteristics: **Slow**
Deposits: ☐ None ☐ Mud ☐ Sludge ☒ **Debris** ☐ Grease
Silt Depth: **1** (in.) Deposits Extent: **Light**
Infiltration: **None** Pipe Seal Cond: **Sound**

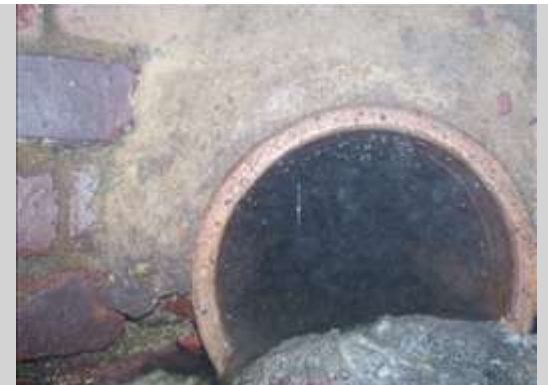
6 O'Clock Inflow

8 in. Circular Gravity Sewer
Pipe In @ 6 O'Clock

Pipe Height: (in.) Direct
Pipe Material: **Clay** ☐ Pipe Lined
Invert Depth: **5.78** (ft.) Flow Characteristics: **Slow**
Deposits: ☐ None ☐ Mud ☐ Sludge ☒ **Debris** ☐ Grease
Silt Depth: **1** (in.) Deposits Extent: **Light**
Infiltration: **None** Pipe Seal Cond: **Sound**
